## <u>Case Studies – On-Line dry chemical cleaning of Air Coolers</u>

## (1) Forced-draft fans, night shift (TX, USA)

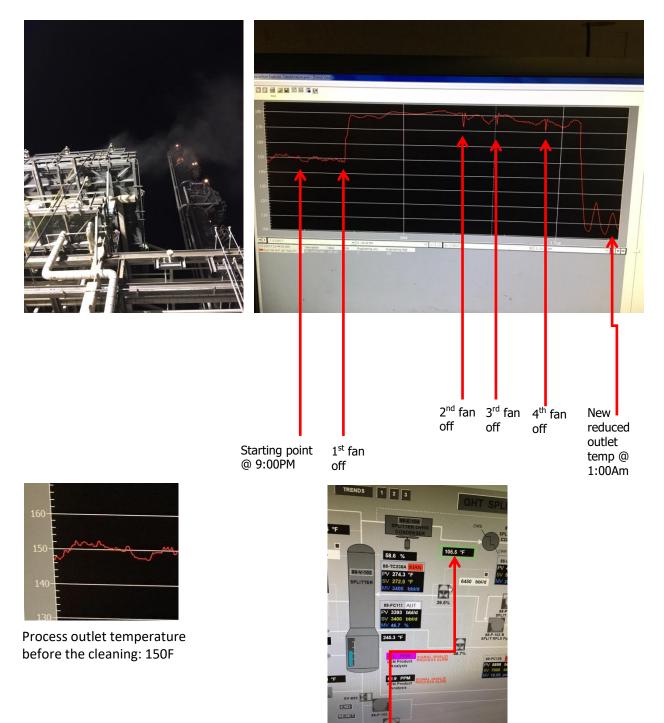
The left picture shows the way it looks from the ground, there is very little opacity and a minor white cloud. The right picture shows how the process outlet temperature drops after each fan been cleaned, and the final temperature drop after all 4 fans have been cleaned.

The process outlet temperature was dropped from 150F before the cleaning to 105F after the cleaning (-30%)

Process outlet temperature after the cleaning: 105 F

4 forced-draft fans were on-line cleaned.

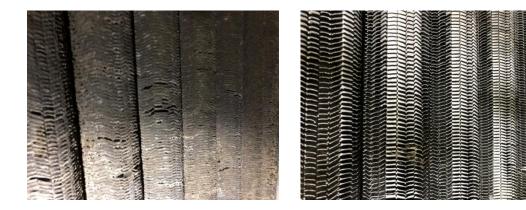
Note the difference between dirty and dry-cleaned fins.

Before cleaning

After cleaning

Dirty

Clean
