## **Damaged** air cooler fins – 2020/2021

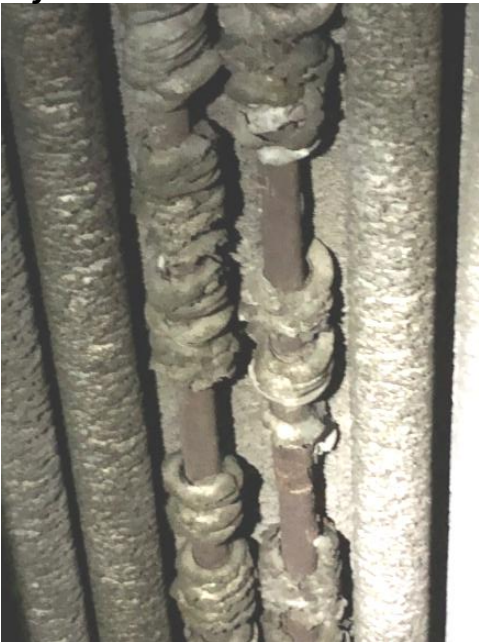
Type: galvanic corrosion

Location: starts in the contact area between fin and tube

fins will start to separate from tube and look like rings, causing the tube to be exposed, then fins will start deteriorate

***Usage of “fin-soap-foam”  
high-pH (>9) soap or foam, or  
surfactant***

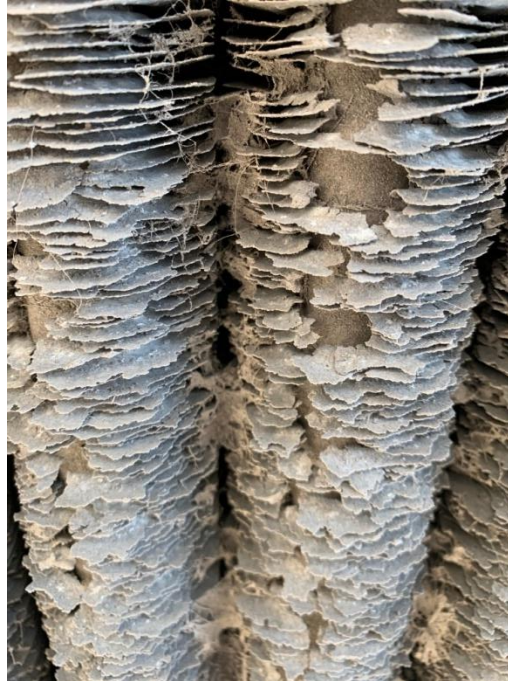
Type: pitting corrosion

Location: start from the bottom of the fin through the entire fin surface

fins get thin and fragile, and gradually get worse

***Usage of low quality fire water,  
chlorides, low pH (<6)***

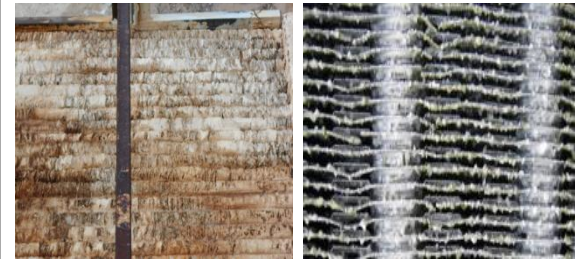
Carbonated fins (“hardness”)

→ ***Usage of “hard” fire water***

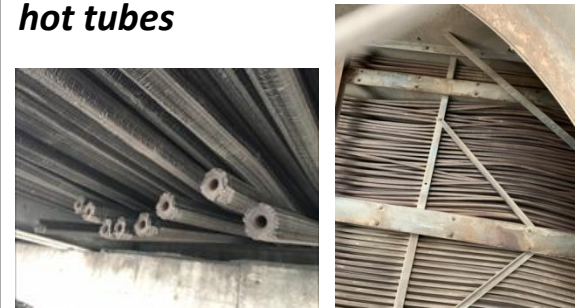
Thermal shock (deformation)

→ ***Applying cold fire water on  
hot tubes***

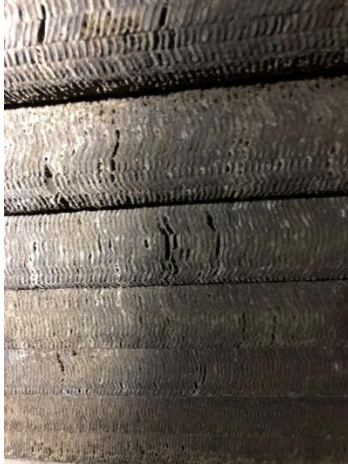
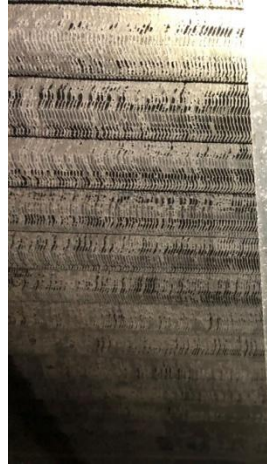
**BEFORE Cleaning**

**SENTRO™ On-Line Dry Chemical Cleaning :**

**Steel fins**

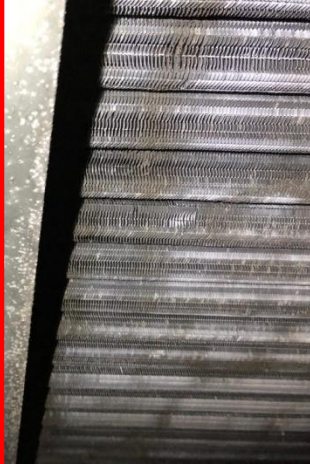
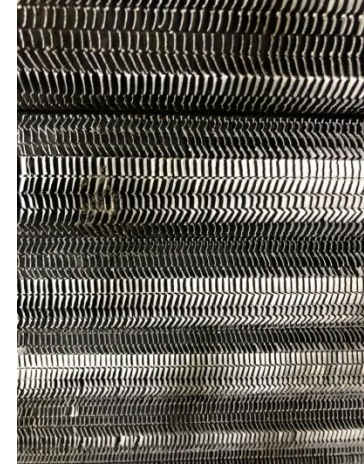
**AFTER Cleaning**

**NO Damage to fins**
